PROJECT PROFILE

PROJECT: Property service: refurbishment of a terrace
LOCATION: Marlbor– Slovenia

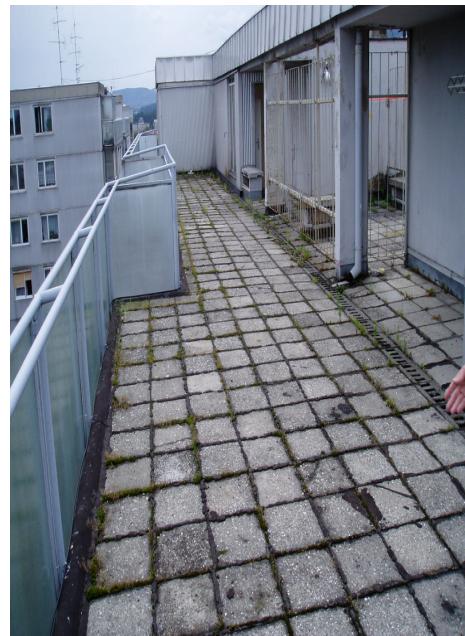
This picture has been taken in Slovenia.

The problem was that the paving tiles of this residential terrace were old and largely damaged.

The paving tiles needed to be repaired and protected. Thortex was asked to provide a solution.

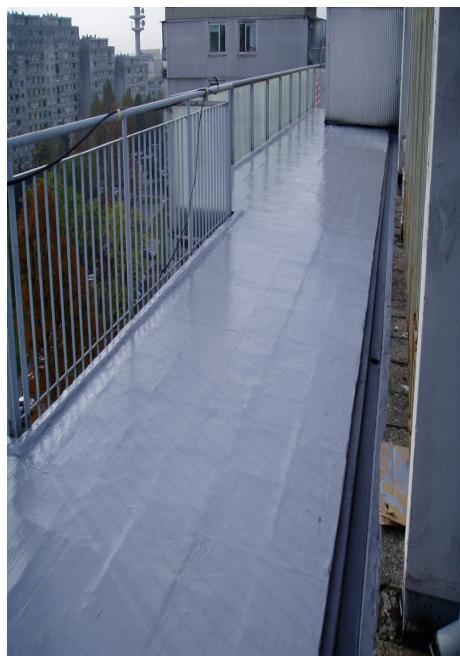
In order to repair the damaged tiles, Floor Tech SFU Primer mixed with sand was applied.

To protect the external terrace from eventual future damage, Floor-Tech S.F.U was used.

Two coatings of Floor-Tech PU were then utilized for abrasion and UV resistance.
