## PROJECT PROFILE

**PROJECT:** Anti-Slip Protection System for Steps

**LOCATION:** United Kingdom

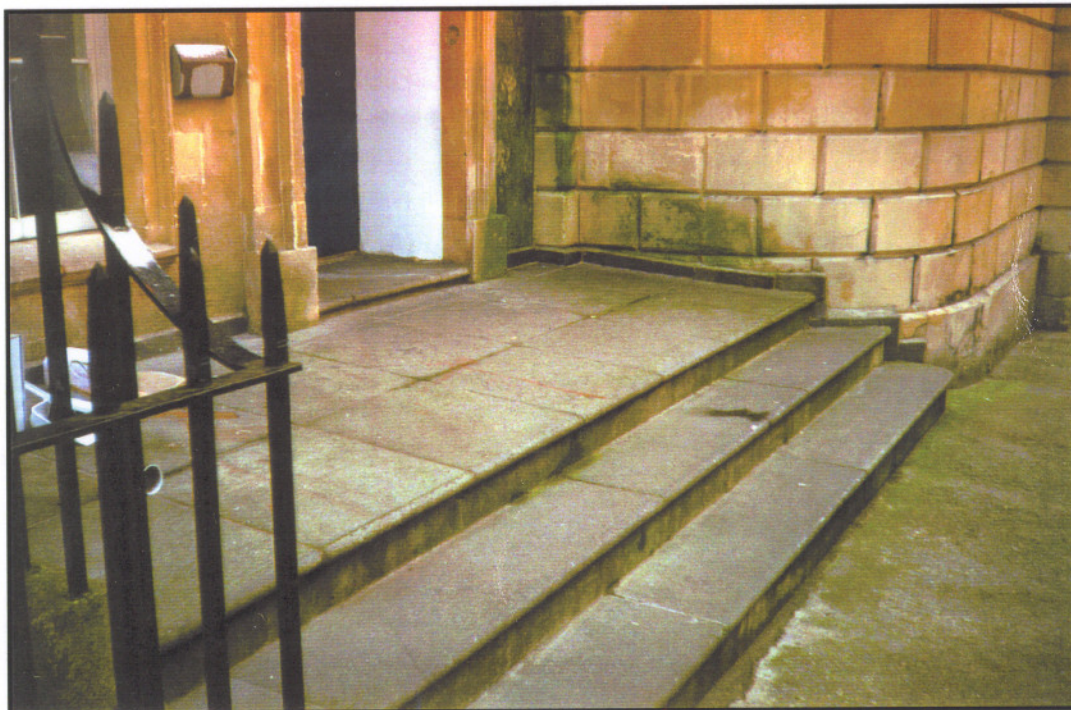
The steps featured in the photograph form the main entrance to a client's offices and had become a safety hazard in wet and icy weather. An anti-slip protection system was sought.

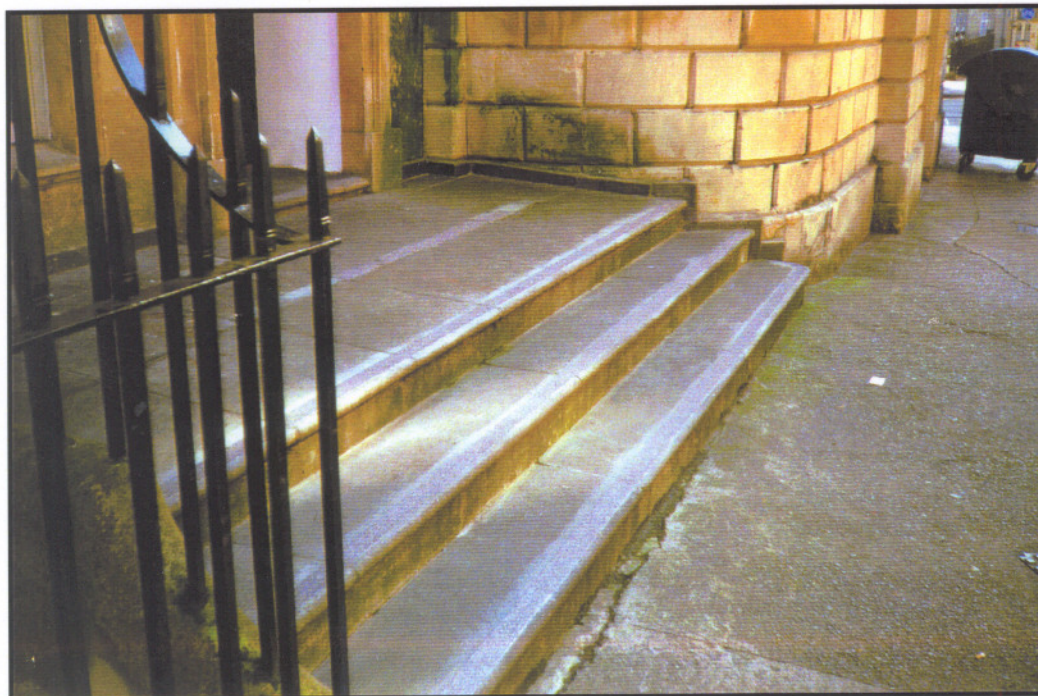
All dirt deposits and other contamination were removed from the concrete; the step nosings were then abraded. These abraded areas were then coated with Grip-Tech. This system is a solvent-free epoxy coating, which has been combined with an abrasion resistant aggregate. It has been specifically designed for use as a slip-deterrent safety system.

The client has reported no further accidents since the application.
