PROJECT PROFILE

PROJECT: Stately Home - Façade Refurbishment
LOCATION: United Kingdom

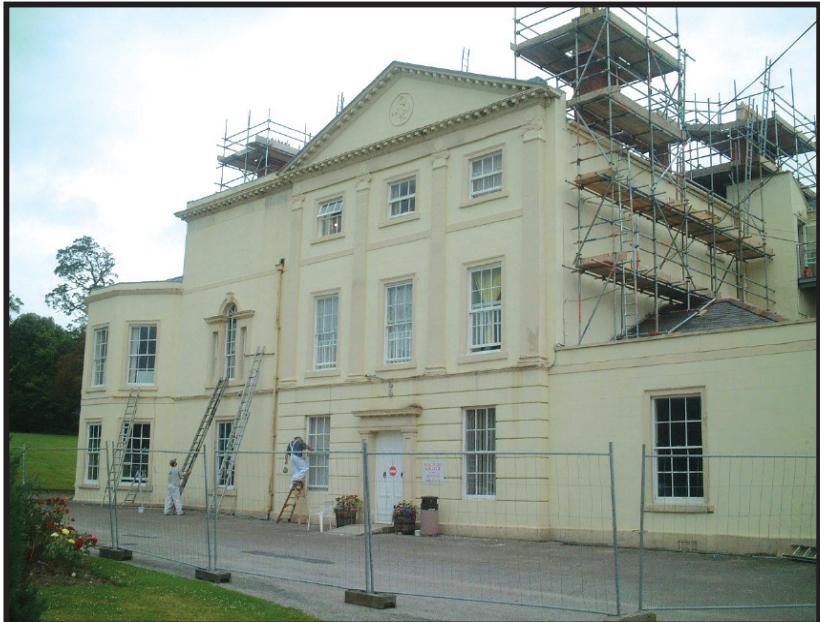
The building required repairs to the concrete render which was cracking and breaking away. A complete coating system was then required to protect this former stately home from the weather in its rather isolated position.
