## PROJECT PROFILE

**PROJECT:** Campa Biodiesel \_ Oil Industry  
**LOCATION:** Germany

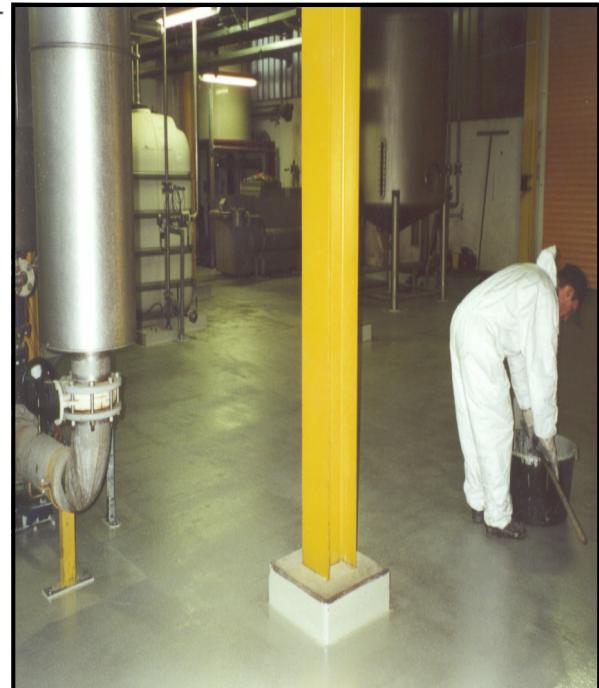
This picture has been taken in a bio diesel factory in Ochsenfurt, Germany.

In order to produce the bio diesel, the manufacturer is using rape oil causing severe abrasion and damage to the factory floors.
