PROJECT PROFILE

Manila Water Company – Balara Filter 1
Waterproofing of Roof deck Area using THORTEX Product-UK
Impex Engineering and Industrial Supply
Thortex Poly-Tech CSM and Thortex Poly-Tech BP Primer

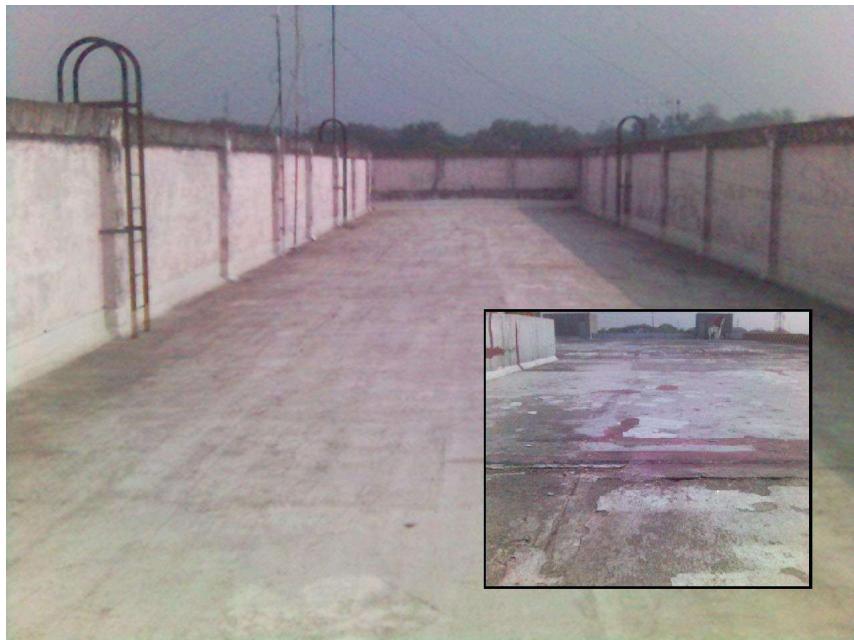
The company was suffering from continual water leak of the roof deck area. This was continual problem due to the extreme weather cycle exposure such as typhoon or just a heavy rain. Also other part of the roof deck area is also in need of repair. Insert picture is the situation of the roof deck.

Our team suggested using Thortex Poly-Tech CSM, a formulated on a complex blend of acrylic resins and aliphatic hydrocarbon polymers reinforced with inorganic fibers and reinforcing agents, to prevent the leakage on the roof deck. Also they used Thortex BP Primer and Thortex Chopped Strand Mat. The repairs proved a complete success thru series of flood testing.
