## PROJECT PROFILE

**PROJECT:** Building Manhattan  
**LOCATION:** USA

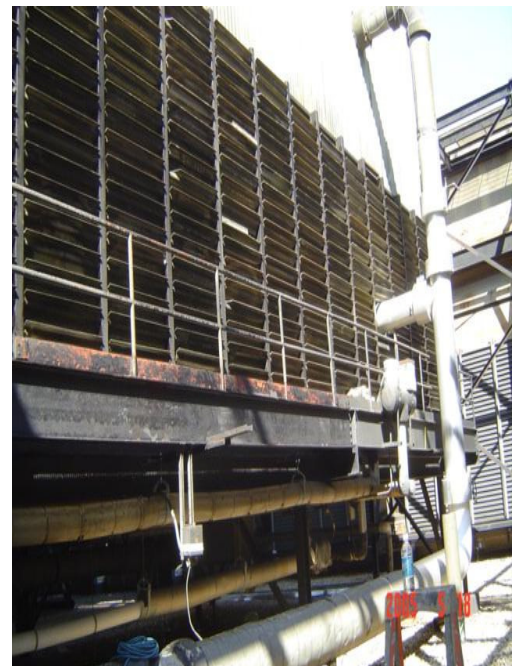
This picture is part of the main Office for Standard and Poor's at 55 Water Street NY.

Thortex has been asked to provide an Anti-Corrosion solution. Nesting Peregrine Falcons are present on site and are appreciated by the Public. For this reason, Thortex was asked to provide a VOC Free Coating solution.
