PROJECT PROFILE

PROJECT: Car Factory - Floor Protection
LOCATION: Spain

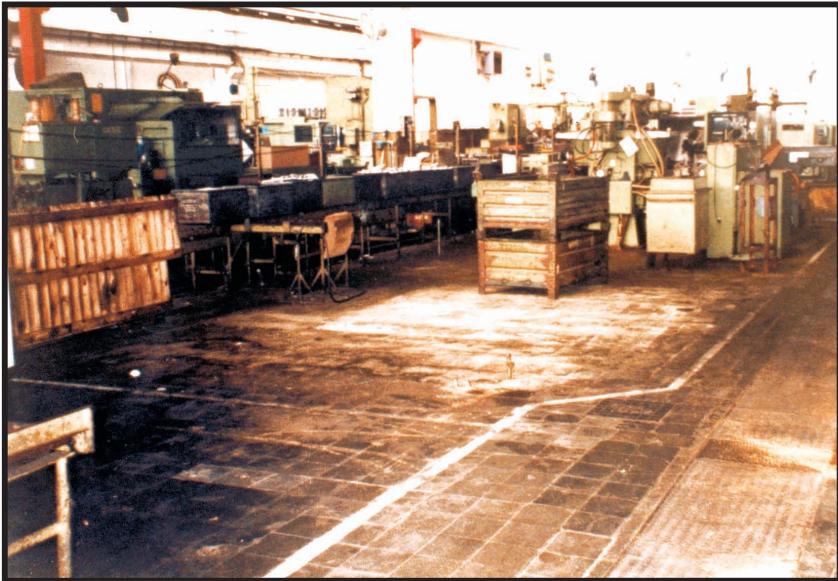
The tiled floor in an area of this car factory in Spain had become badly damaged due to the high level of use.

The client required a high performance self-levelling system, which would completely resurface the worn and eroded floor and offer long-term protection.

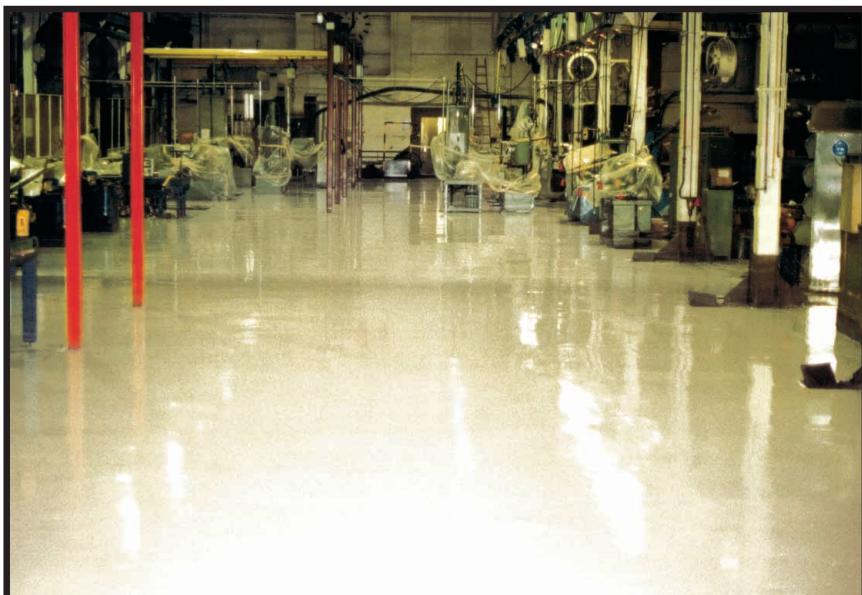
The tiles were suitably prepared, ensuring the surface to be coated was clean, dry and free from contaminants and treated with Floor-Tech SP Primer. Our three component, solvent-free epoxy self-levelling screed Floor-Tech XSL was then applied.

Floor-Tech XSL provides outstanding abrasion, impact and chemical resistance. It also exhibits the ultimate application and levelling properties.
